Rudder and Rudder Horn Repair on the Bulk Freighter Sophia D

By Uwe W. Aschemeier and Kevin S. Peters

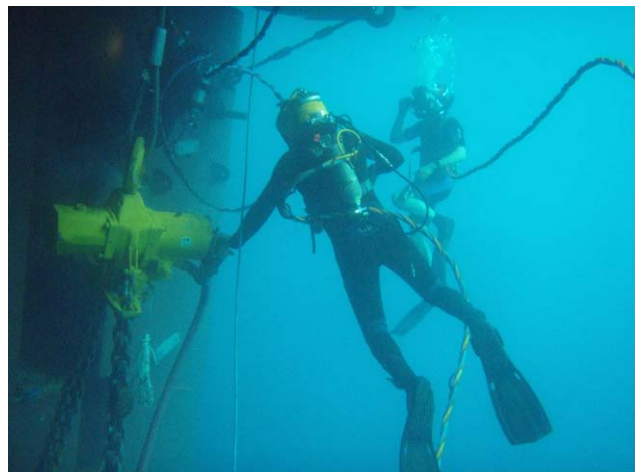
Diver operating a 25 ton air chain hoist during the removal of the rudder

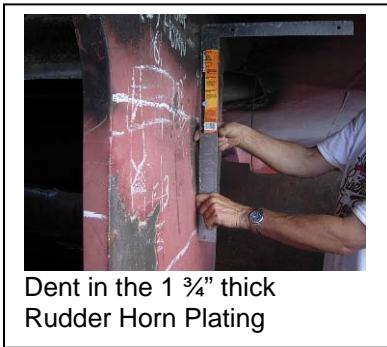
Since the rudder horn was bent 8 inch starboard, 2 inch aft, the horn was cut from the vessel at approximately 12 inch below the hull penetration, and an approximately 8 inch tall section was removed. During the cutting operation the lower, 25 ton portion of the horn was supported vertically by six 15 ton load rated turn buckles. For side alignment, four 10 ton chain hoists were placed fwd and aft at the port and star board side between the hull plating and the lower casting at an approximately 30° angle.

The rough cut was ground smooth, and a 45 bevel was prepared at the upper part of the rudder horn plating. For the lower part of the joint, the 200 mm tall plate insert needed to be prepared with a 45 bevel.

An 8 inch tall plate insert was installed to remove the "dog leg" so that the pintle bushing could be realigned with the upper neck bushing.

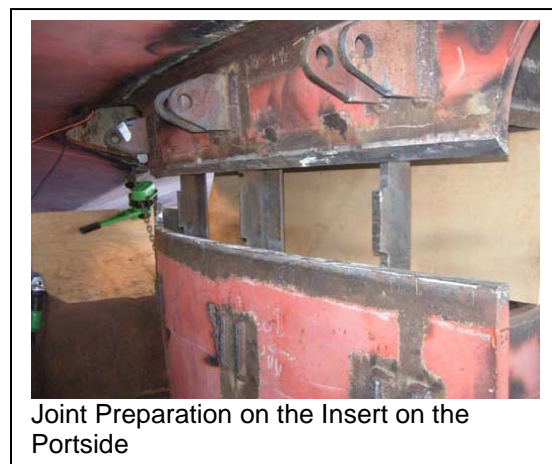
The rudder horn nose plate was found to be cracked and had to be copped out and replaced. The steel thickness for the rudder horn plating and the nose plate was 1 3/4".

The 8 inch tall plate insert on the port and starboard side, as well as the nose insert plate were tacked in place and strong backs were welded onto the back side of the joint. Run off plates were welded at the ends of the welding joints.

Joint preparation was a single bevel groove weld with a 45° opening angle on top, to use the lower part of the joint as a shelf. The root opening was held at approximately 4 mm.

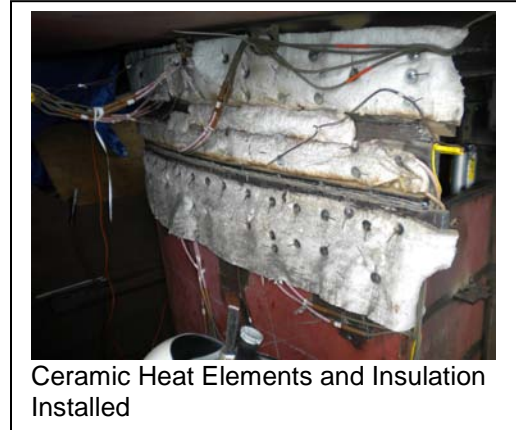
Ceramic Heat Elements and Insulation Installed

After the alignment of the inserts was confirmed, ceramic heating elements and insulation pads were installed, to maintain the pre-heat temperature and to reduce the cooling rate of the finished welds.

After approximately two hours the preheat temperature of 225°F was achieved and the root could be welded. Preheat and minimum interpass temperatures were maintained during the welding operation for a distance not less than 3 in. [75 mm]) in all directions from the point of welding.

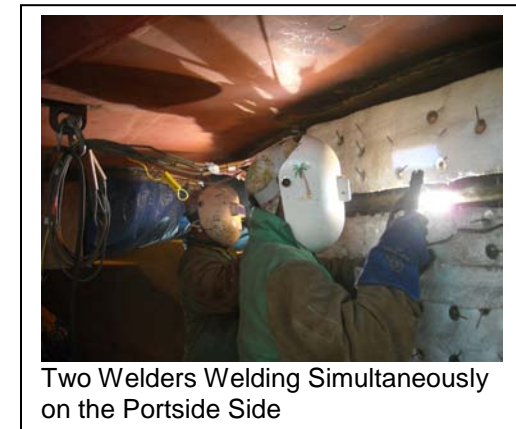
Two Welders Welding Simultaneously on the Portside Side

The two upper joints on the port and starboard side were welded first. The root passes on the upper weld seams were welded simultaneously by one welder on each side, welding in a predetermined welding sequence, starting from the center to the outside. Fill and cover passes were then welded by four welders at the same time, 2 on each side Welding in two 12 hour shifts.

The welders started in the center of the joint, moving outwards. The challenge was to convince welders it was not a race and each welder had to weld at the same speed. It took 35 passes and approximately 24 hours to fill each of the 12 foot long joints.
