Rudder and Rudder Horn Repair on the Bulk Freighter Sophia D

By Uwe W. Aschemeier and Kevin S. Peters

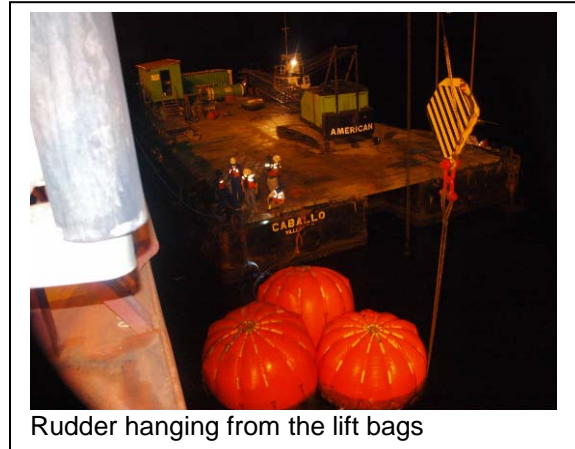
The underwater removal of the rudder was featured on the National Geographic Channel in a show called "The Worlds Toughest Fixes"

The freed rudder blade was lowered on the four air hoists and transferred aft to 70 tons Lift bags. The rudder blade was towed to the backboard side of the ship and a preset rigging was attached to perform a two crane pick using two of the ship's 35 ton cargo cranes. The rudder blade was loaded onto the barge and brought to the ship yard.

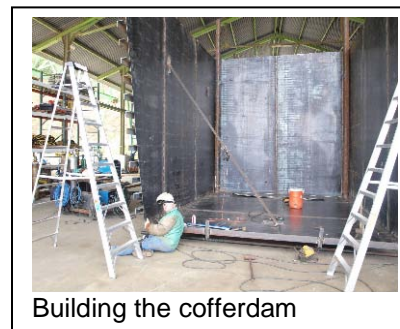
A Cofferdam displacing 130 cubic yards of water was engineered by a marine engineer specifically for this job, to be installed around the rudder horn, once the rudder was removed. The 23,000 pound cofferdam was built in facilities of Miami Diver in Curacao. The approximately 15 feet long, 13 feet wide, and 14 feet tall cofferdam was built out of ¼" (6.35 mm) thick ASTM A36, reinforced with 4X4X3/8 angles at the bottom and the side walls.

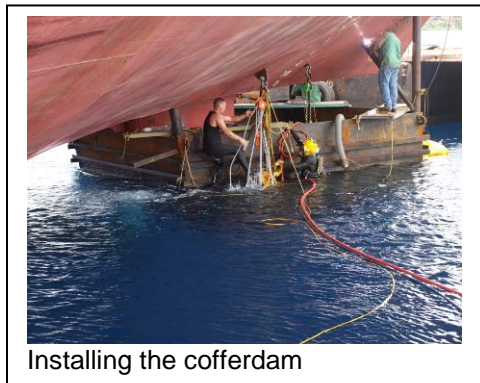
The cofferdam was built while the vessel was being towed from Brazil to Curacao.

After the cofferdam was finished, it was transported with Miami Diver's crane barge to the vessel, lowered into the water, lifted up and welded to the ship's hull. Once installed, 30 tons of cargo had to be moved to the forward compartments allowing the ship to trim the cofferdam three feet above the water line. The cofferdam was dewatered to enable evaluation of the damage to the rudder horn
